BUILDING-STRUCTURE INVENTORY FORM

1. BUILDING NAME(S): _____
2. COUNTY: Monroe TOWN/CITY: Greece VILLAGE: ---
3. STREET LOCATION: 553 Denise Road (S.E. corner of Chalford Rd.)
4. OWNERSHIP: a. public ☐ b. private ☒
5. PRESENT OWNER: William & Rose Raymond ADDRESS: (Same) Rochester, NY 14616
6. USE: Original: residence Present: residence
7. ACCESSIBILITY TO PUBLIC: Exterior visible from public road: Yes ☒ No ☐
Interior accessible: Explain private residence

Town of Greece Historic Sites Survey
Monroe County, New York
553 Denise Road
page 4

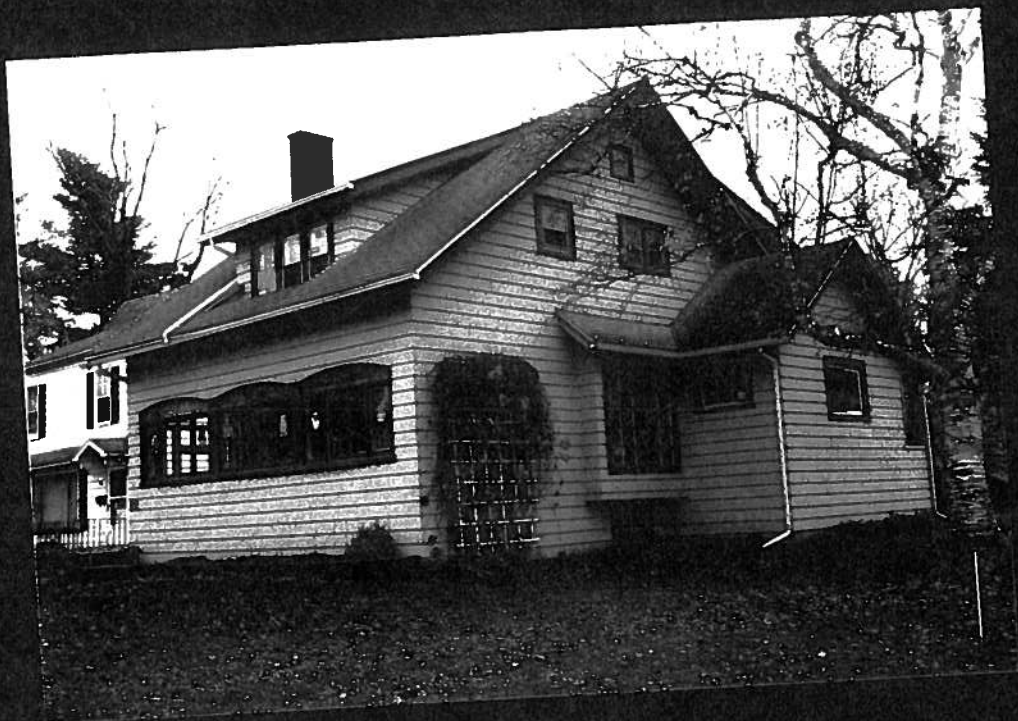
12. PHOTO:

18. This 2-story residence has wide composition siding and (probably) a concrete block foundation (not visible). The present contemporary siding was most likely installed over original wood shingle or clapboard cladding. It features a broad-pitched, side-gable roof with shed-roof front and rear dormers. Fenestration is asymmetrical and has a variety of window sizes, from square, diamond-paned sash (E. and W. elevations) and larger rectangular 1/1 sash, to the 25-pane picture window (later addition?) on the W. elevation.

The full-width recessed front porch is enclosed and features three distinctive 4-panel windows with arched transom containing decorative leaded glass. The porch may have been originally open, but the present glass windows appear to have been installed near to the date of construction. The one-story southeast addition with rear porch has a concrete block foundation and appears to be a later (post-World War II?) addition. A brick chimney is located on the east elevation.
